# Bauman Hall Condition Assessment Report

March 20, 2020

Reclaim Community has retained LHB to provide a condition assessment report for Bauman Hall in Jasper, Minnesota. The building was originally constructed in the 1880s in a quarry town called North Souix Falls, approximately 3 miles to the northeast of Jasper. Following the failure of the quarry, the building was moved to Jasper around 1908. Historically, the building served as a general/grocery store at ground level and a multi-purpose assembly space at the second floor. Following the opening of a new gymnasium/auditorium at the Jasper School in 1939, the second story assembly function greatly diminished and it appears that very few improvements have been made to the second floor since. In the early 1980s the ground floor of the building was converted to Jasper's senior center. It remained the senior center until 2009 when, due to structural concerns and upkeep costs, the city divested itself of the building. The building has remained largely unused since.

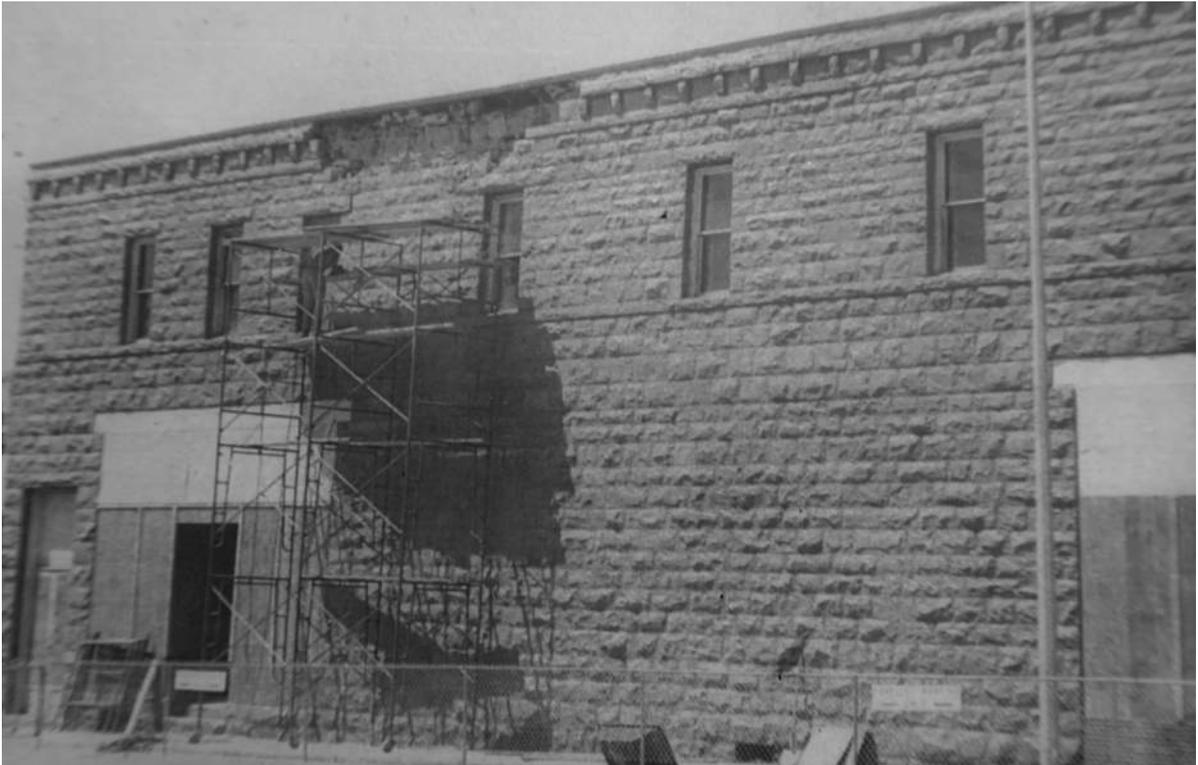
*Figure 20 Damage to the east wall c. 1981 (courtesy Jasper Historical Society)*

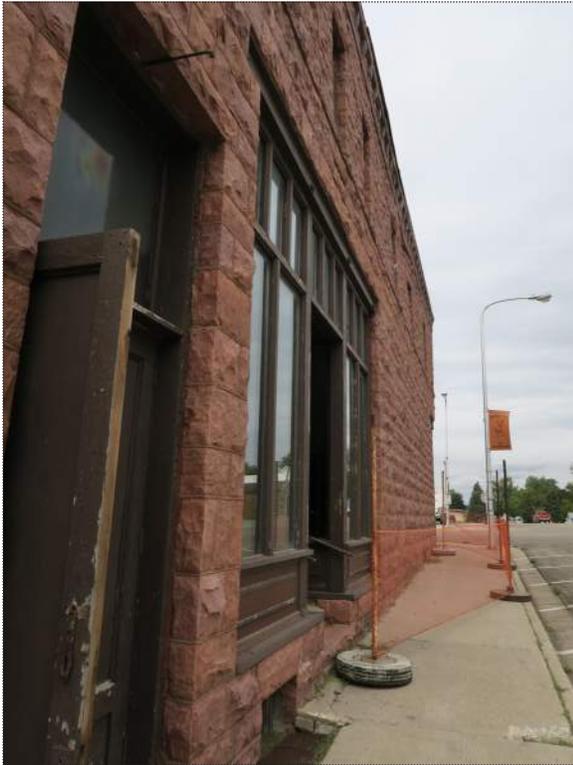
*Figure 23 Detail of sidewalk at east facade. Note basement window well at bottom of photo*

Along the east and south facades of the building there are several locations where ground level windows originally provided light into the basement. Some have been infilled with brick, while others have been boarded over (Figure 23). It is recommended that all be infilled with an appropriate aggregate base and concrete at the walking surface and masonry to match existing at the wall in order to prevent further water infiltration. Infilled masonry at the wall should be set back from wall surface 1 inch to clearly delineate infill from original wall surface.

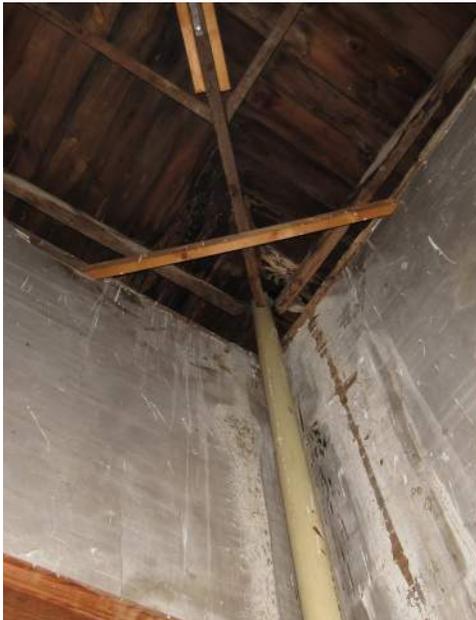
*Figure 25 Underside of southwest corner of roof, note water damage around vent penetration*

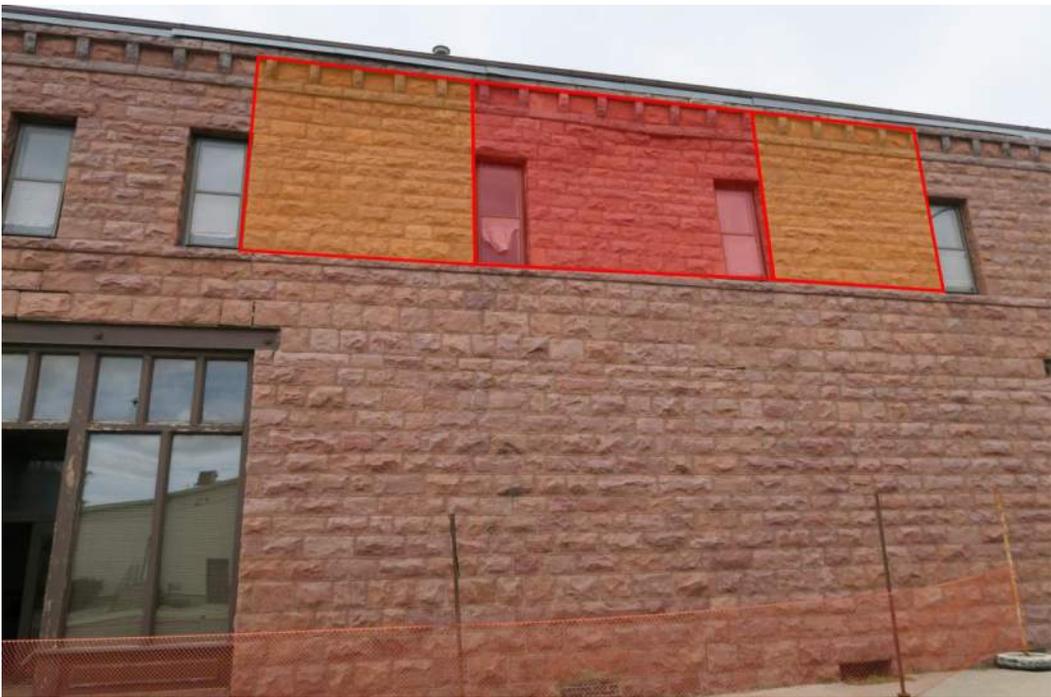
*Figure 28 Showing areas of deflection at east wall*

The upper east wall bow is likely the most challenging condition in the building. A strict structural analysis of this wall is beyond the scope of this report, but from visual observations, it is possible that

the masonry in this area is unstable. Due to its potentially unstable condition and load-bearing role, the masonry in this area is deemed to be in poor to unacceptable condition. It is recommended that a barrier be placed at grade to restrict access to the sidewalk adjacent to the entire east wall until a repair is made. Also, it is recommended that access to the interior of the building be restricted to those who understand the inherent risk of this potentially unstable condition. Due to the scale of the repair project and the possibility that it could be a matter of years before a proper repair is completed for this wall, it is recommended that a licensed engineer prepare a shoring plan for this area in order to stabilize it until appropriate repair measures can be complete.

There are several possible contributing factors to the condition of the east wall. Based on limited observations, the interior rough stone wythe likely has poorly fitting stone, a greater percentage of soft mortar and pockets with no mortar or stone. It is likely that this rough wythe, being lower quality, has deteriorated and crushed downward and inward under the weight it is carrying. This internal deficiency and movement could have, in turn, brought the exterior wythe inward with it.

The first recommended course of action is to remove the finishes at interior of the building at this location to better inspect the condition of the masonry. As previously mentioned, the modern furring below this area at the first floor has completely failed and collapsed, leaving this wall exposed from the interior. It is also recommended that the plaster and lath be removed at this area at the second floor in preparation of reconstruction of this area and in order to inspect the interior face of the stone at this location. It should be noted that a previous hazardous materials report has indicated that the plaster at the second floor contains asbestos, so this plaster should be abated by a licensed professional. The damaged area at the east wall should be the first area to receive this treatment, but this is a recommended approach for the entire building, as inspection and repointing may be required at other areas at the interior of the building. It is believed that the original plaster and lath has been removed at the entire first floor in order to install

The deflected masonry wall in the damaged area should be dismantled and re-laid plumb and level. For all masonry repairs in the building it is critical that a chemical analysis be performed and mortar consistent with the original masonry be used in repair. To be compatible with masonry of this era, mortar often must be quite soft by modern standards.

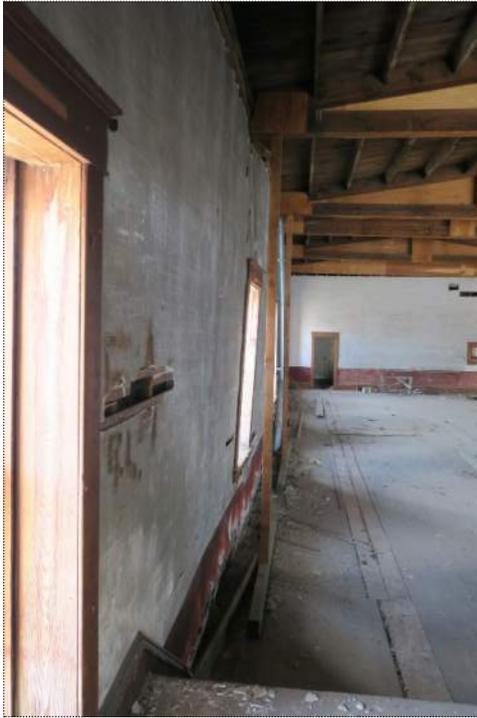
*Figure 29 Showing deflection at the interior of the east wall*

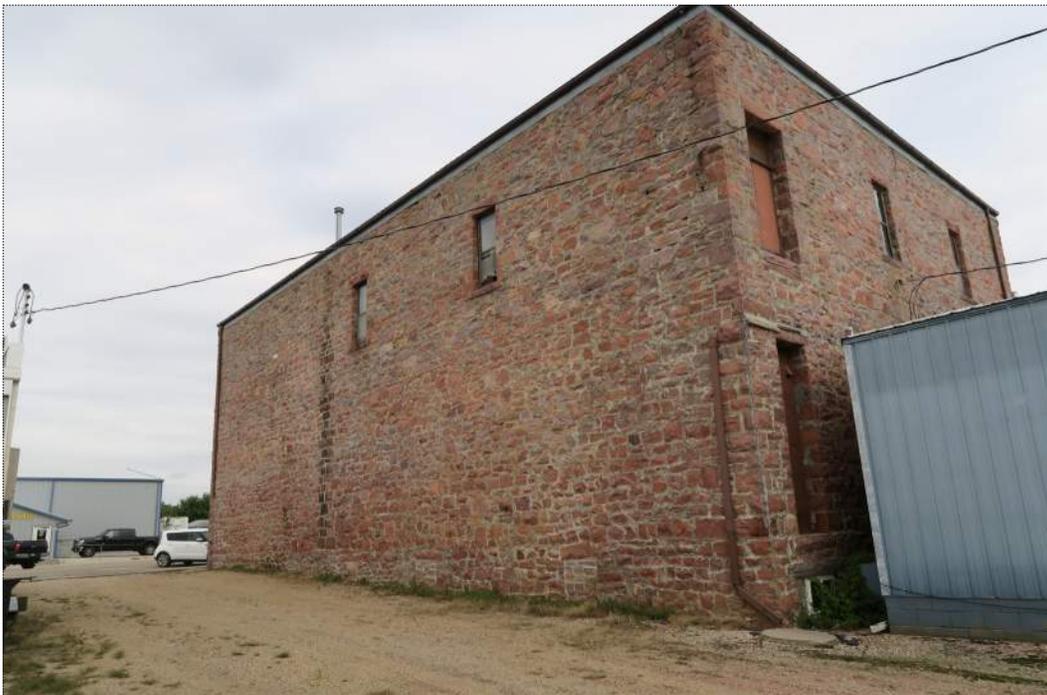
On the south and west exterior elevations, the masonry consists of irregular, roughly rectangular stone and thicker, irregular mortar (Figure 31). These walls generally appear to be in good condition with only minor areas of repair to mortar required.

*Figure 31 Showing rough cut rubble masonry*

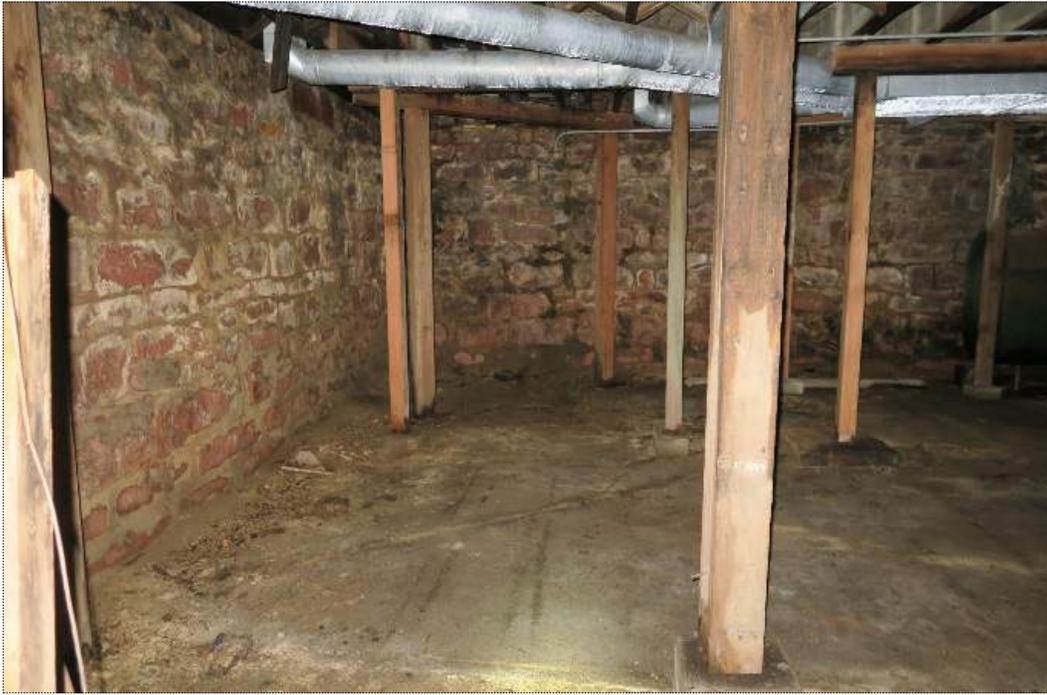
On the basement interior, similar to the south and west exterior, the masonry consists of irregular, roughly rectangular stone (Figure 32). At various locations in the basement, mortar joints are loose or

*Figure 32 Showing foundation masonry and typical support posts at basement level*

The basement foundation walls are in average to poor condition. They are not, however, in unexpected condition for a structure of this age. Over time, the effects of moisture, temperature variations and settlement all contribute to mortar deterioration in stone masonry walls. There is no noticeable bowing but some of the mortar between the stones is loose, deteriorated or missing. In some locations, re-pointed mortar of various types has been used. Accordingly, the lower level masonry walls should be re-pointed with compatible mortar. These defects do not appear to have significantly compromised the structural integrity of the wall now, however if they remain unrepaired and worsen, they could lead to structural problems in the future.

Due to the moisture mentioned above at the basement, the walls appear to require approximately 50%-70% repointing. At the exterior walls, excluding the areas at the east discussed above, approximately 10% appears to require repointing, particularly along the areas where the walls meet the ground. Repointing will also likely be required at the interior walls following removal of finishes and inspection. Mortar shall match the historic mortar in strength, composition, color, texture, and tooling.

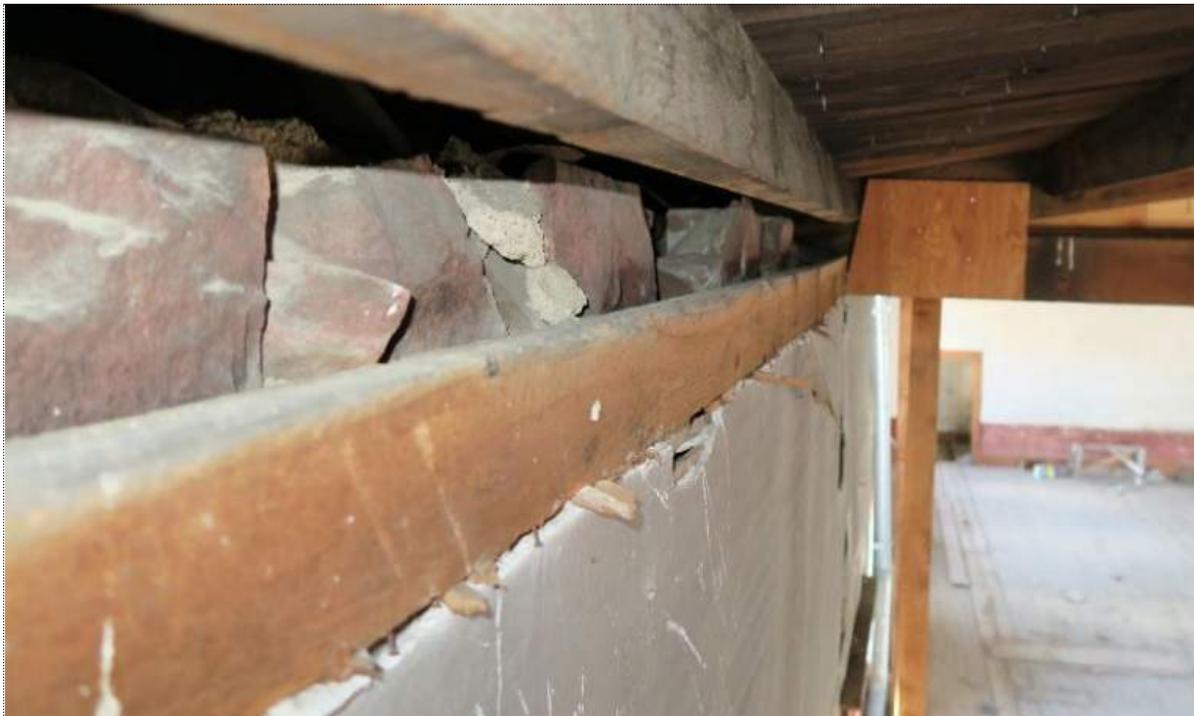
*Figure 37 Top of stone near bearing point for roof trusses*

At the top-of-wall, visible near the roof truss bearing, the interior masonry wythe consists of irregular stone pieces loosely bonded with mortar (Figure 37).

At the top-of-wall, near the roof truss bearing, the masonry is irregular and in poor condition. To enhance the integrity of this area, the stone pieces should be re-mortared solid with compatible mortar.

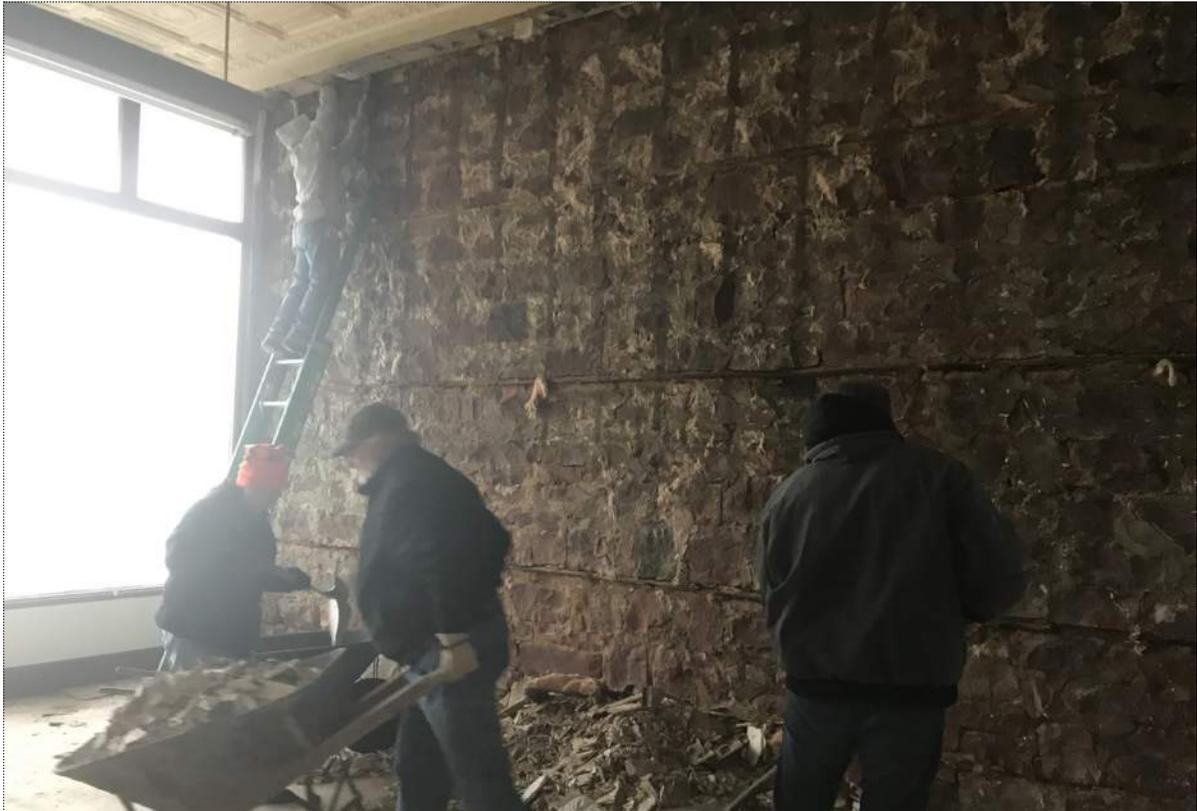
At the interior face of the ground-level east wall, where the interior finish is damaged, the masonry construction is visible. Here, the masonry consists of less regular, roughly rectangular stone. A horizontal band of 1x wood lumber is visible. Historically, these wood strips were placed at intervals to provide a nailing surface for the furring required for a lath-and-plaster finish. The nailing strip here has rotted and deteriorated. Access to this area was limited and, although the exterior wall at this location shows no significant defects, there is a small horizontal gap at the nailing strip and the interior masonry wythe may be deflecting inward slightly (Figure 35). In December of 2019, following the project team's site assessment but prior to the finalization of this report, the non-historic interior furring at this wall failed and collapsed completely (Figure 38).

*Figure 38 Interior wall at northeast corner after December 2019 collapse of modern furring assembly*

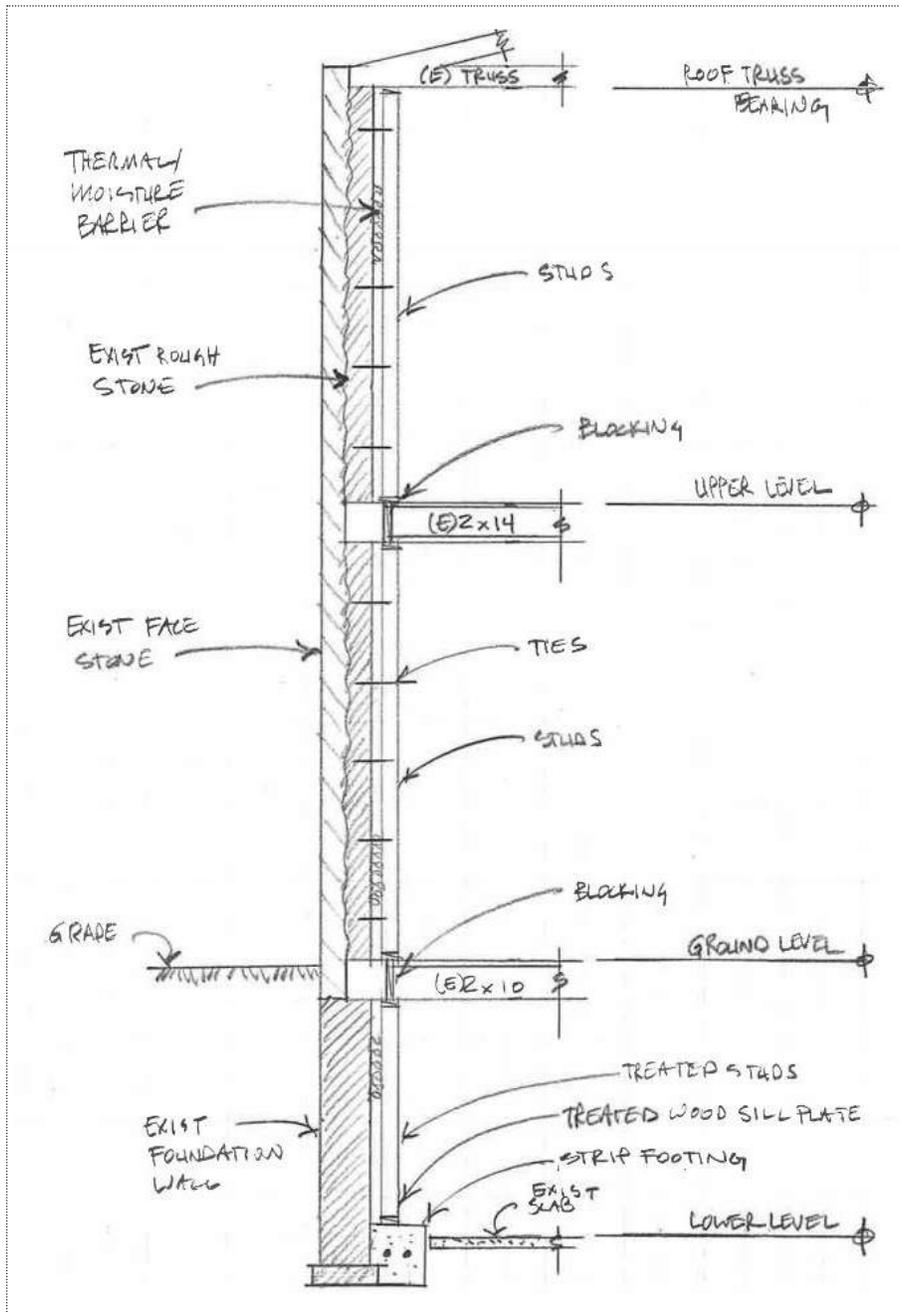
Figure 39 Wall section illustrating potential strategy for structural reinforcing of masonry walls.

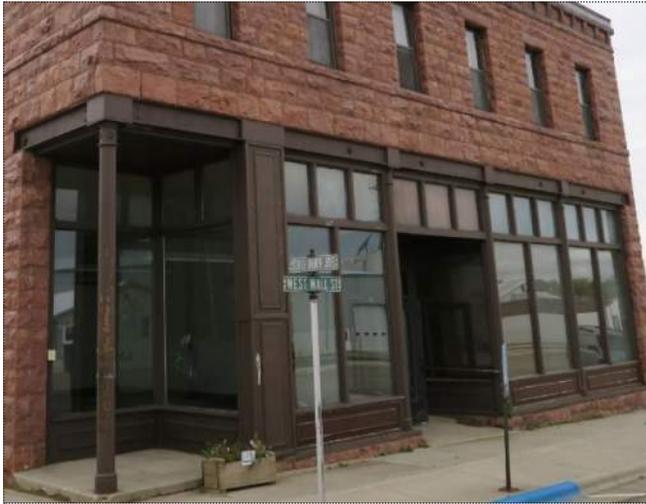
Figure 40 Steel beam and columns at the north facade

On the north face of the building, four steel columns support steel beams which in turn support the masonry above (Figure 40). The steel columns are 8-inches outside diameter and the steel beams are 12-inches deep. The steel members on the north facade are in good condition and show no signs of excessive deflection. Intermittent steel fasteners, in a floral shape, are visible at the beam webs. These fasteners are likely tie rod connections to the upper level interior wood floor framing and diaphragm. The beam-to-column end connections have been concealed.

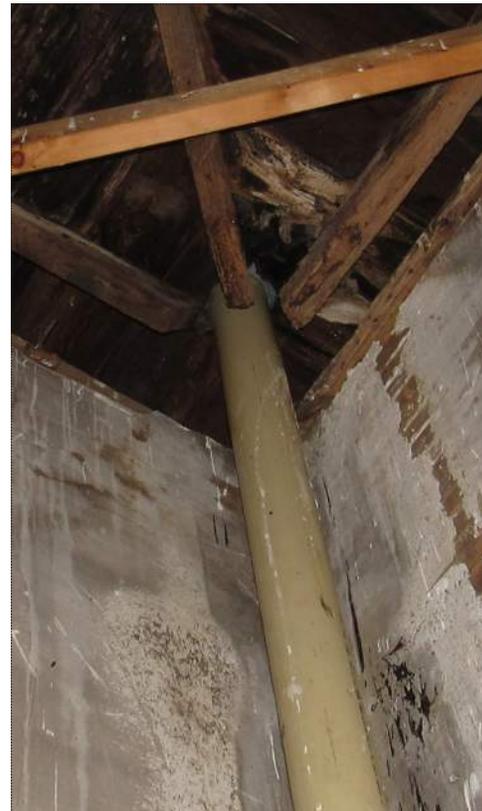
*Figure 50 Damaged roof framing due to vent addition at southwest corner*

Additionally, the downspouts draining the roof are in poor condition and missing in some locations. It appears that more downspout locations than are currently present may be required to properly drain the roof. The gutters were not directly observed, but it is likely that they are in similar condition to the downspouts. It is possible that the gutters are overflowing at the area above the wall section at the east, and contributing to the failure of that wall. It is recommended that roof detail at the perimeter be closely inspected and the flashings and gutters be replaced with the appropriate number of downspouts. It is also recommended that all roof penetrations be evaluated and removed if obsolete. If the penetrations are to remain, they should be reflashed. The penetration at the southwest corner is also compromising the roof structure. It should be moved and the cut roof members should be repaired.

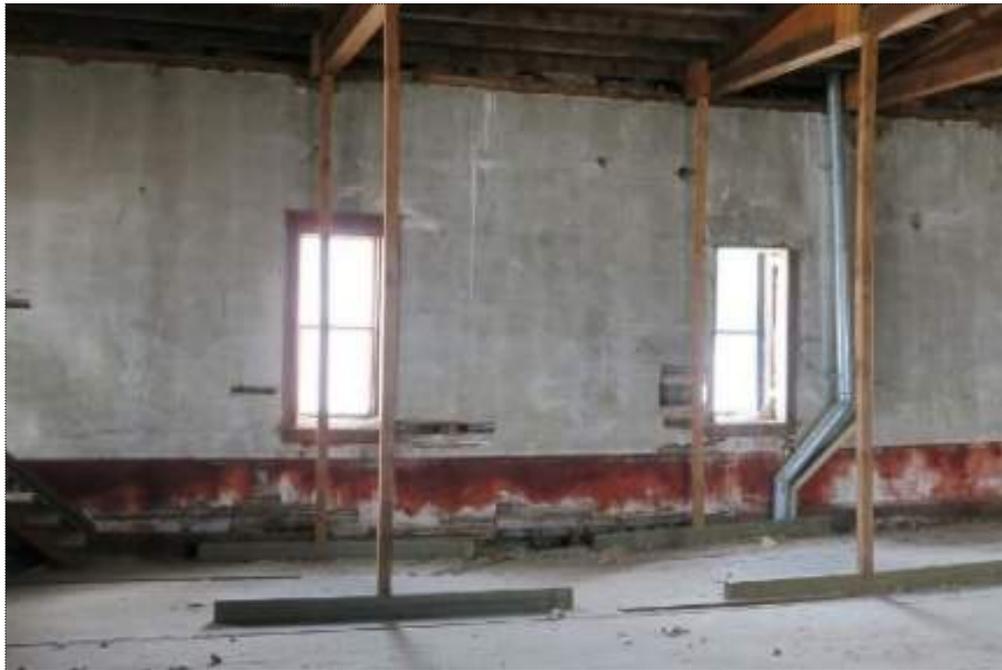
*Figure 51 Shoring at location of depressed flooring*

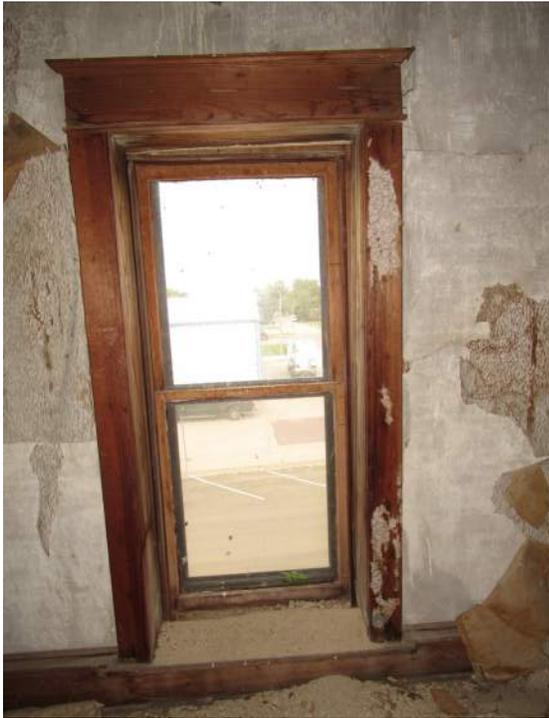
*Figure 53 Second floor window behind stage. Note significant powdered mortar at stool. This window been wallpapered on its casing. This is not typical*

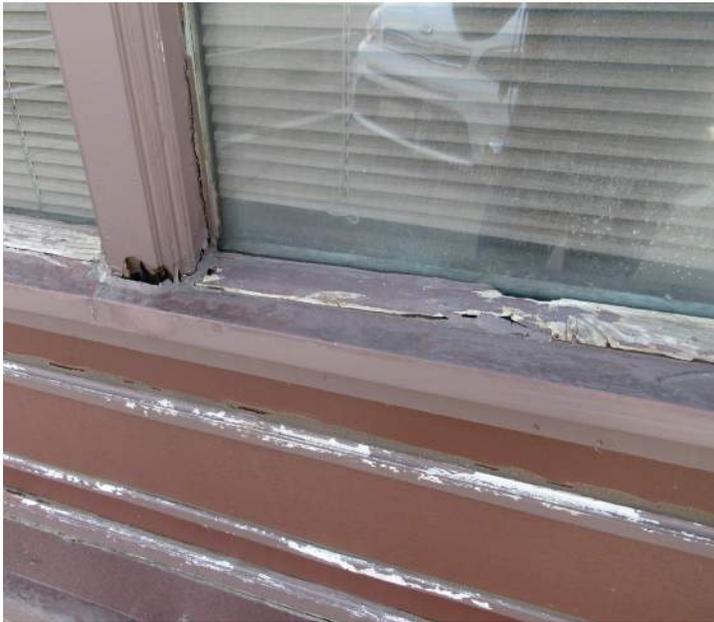
*Figure 55 Typical deterioration at storefronts. Note slope of flashing back towards window and rot at base of vertical members and at horizontal stops*

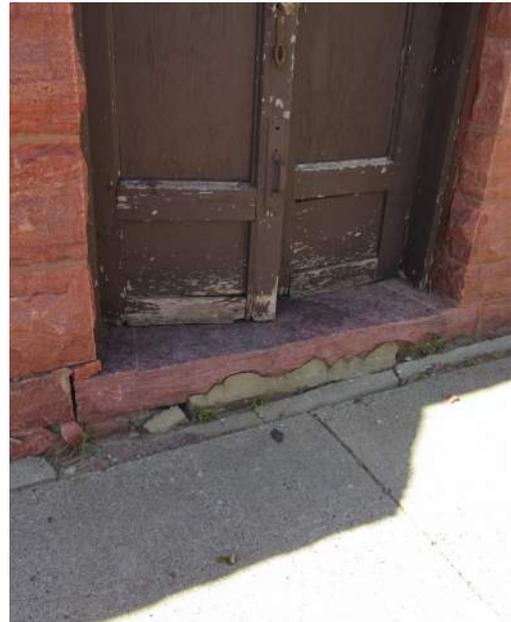
*Figure 56 Detail of deterioration at door to stairs to second floor*

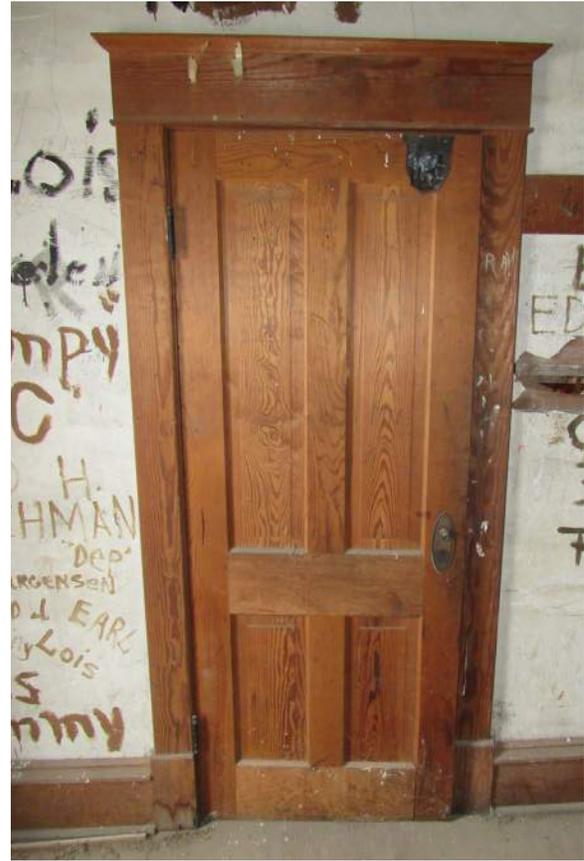
Figure 58 Typical second floor interior door. Note burned area, which directly corresponds to placement of gaslight fittings when door is open

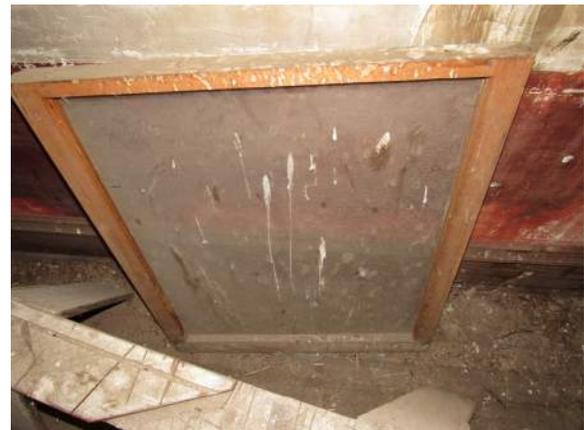
Figure 60 It appears that original sashes may have been removed and placed at the interior. These should be repaired and refitted in their original locations

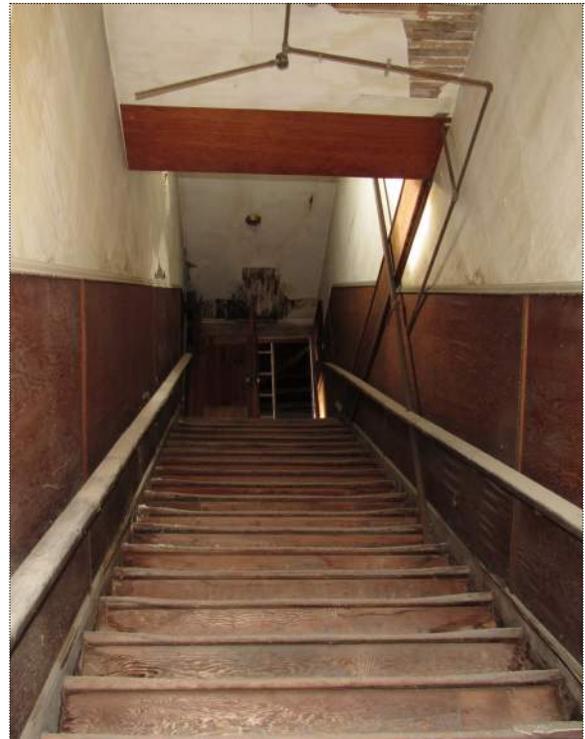
*Figure 64 Plywood wainscot and worn stair treads at stairway to second floor*

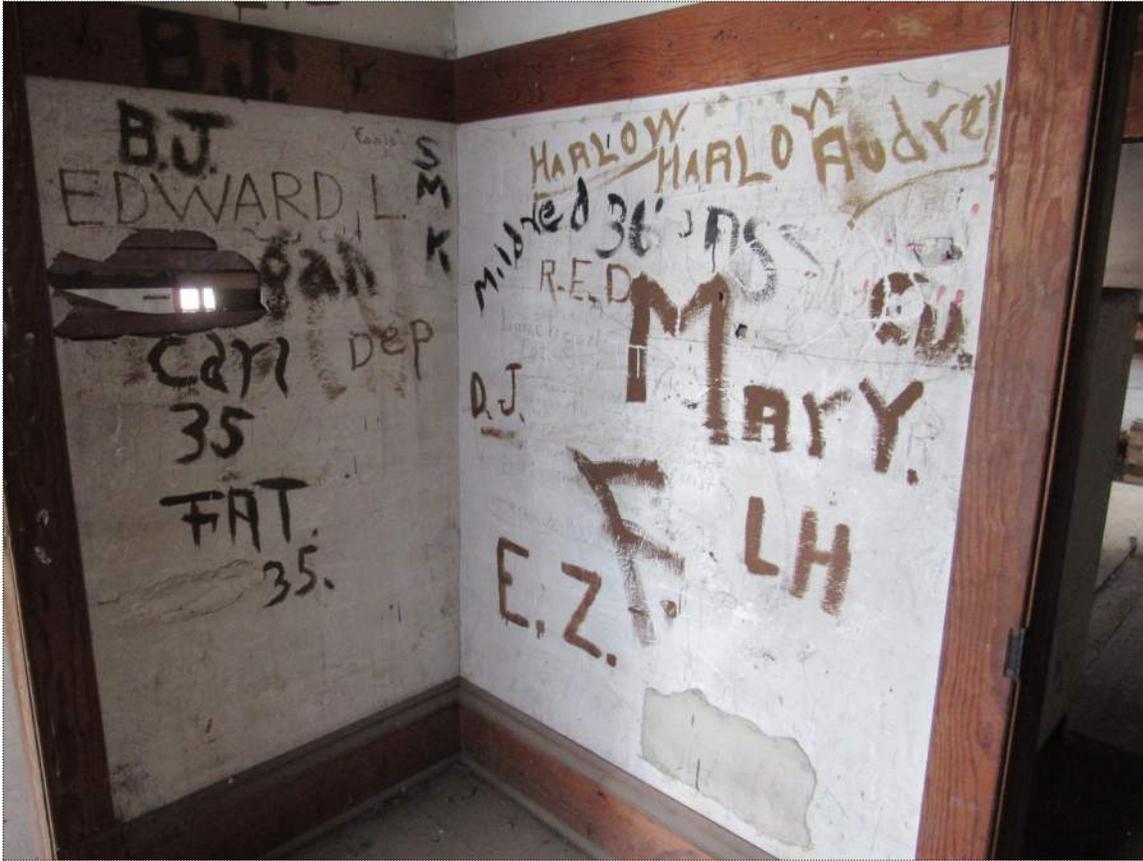
*Figure 65 Typical condition of plaster at interior of side-stage rooms with wall writing*

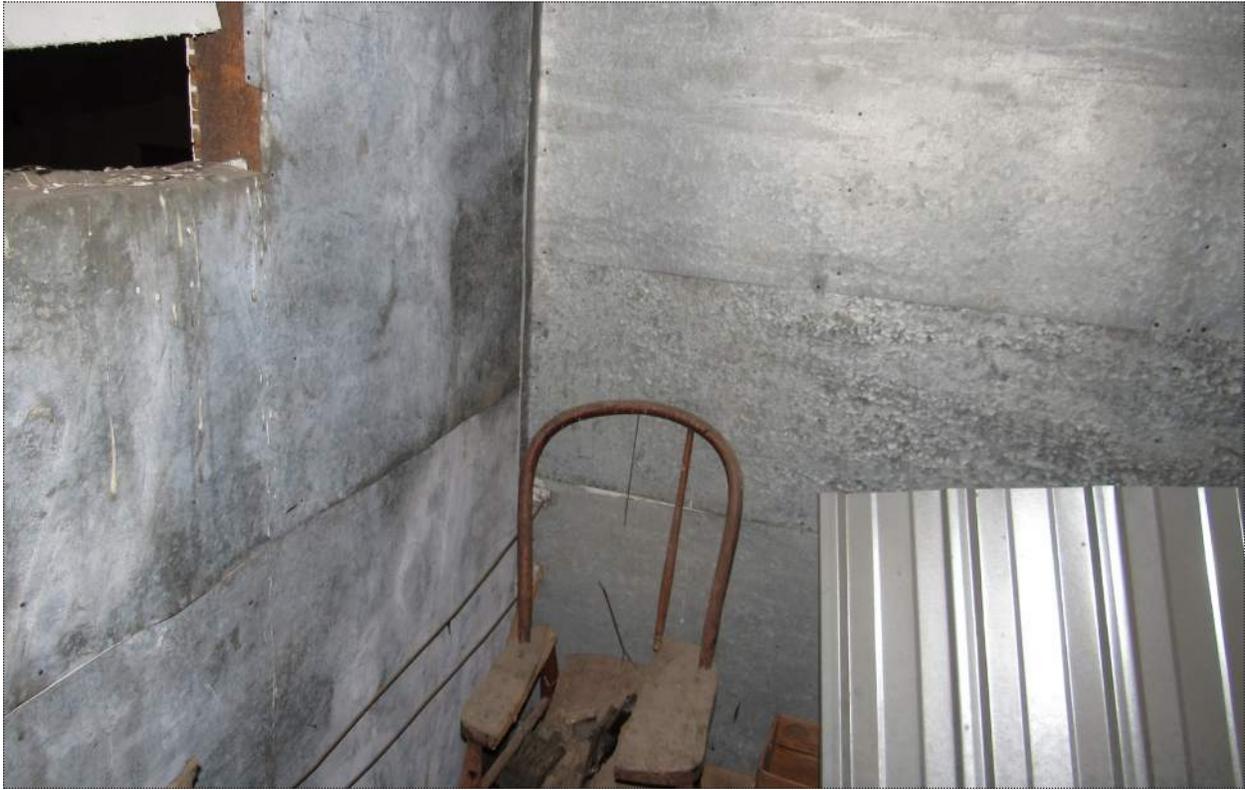
Figure 69 Interior of the projector room. Note the knob and tube wiring penetrating the sheet metal walls, creating the possibility for truly horrific electrical incidents
