# Bauman Hall Condition Assessment Report

March 20, 2020

Reclaim Community has retained LHB to provide a condition assessment report for Bauman Hall in Jasper, Minnesota. The building was originally constructed in the 1880s in a quarry town called North Souix Falls, approximately 3 miles to the northeast of Jasper. Following the failure of the quarry, the building was moved to Jasper around 1908. Historically, the building served as a general/grocery store at ground level and a multi-purpose assembly space at the second floor. Following the opening of a new gymnasium/auditorium at the Jasper School in 1939, the second story assembly function greatly diminished and it appears that very few improvements have been made to the second floor since. In the early 1980s the ground floor of the building was converted to Jasper's senior center. It remained the senior center until 2009 when, due to structural concerns and upkeep costs, the city divested itself of the building. The building has remained largely unused since.

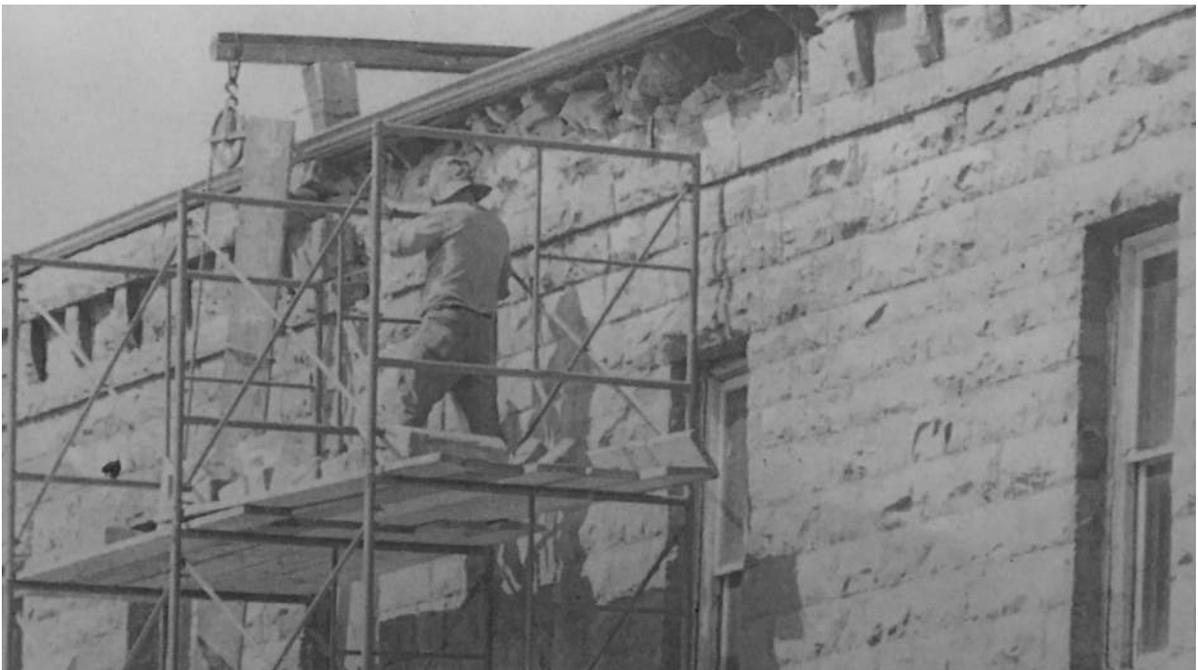
*Figure 21 Repair work being undertaken at the east wall in 1981 (Courtesy Jasper Historical Society)*

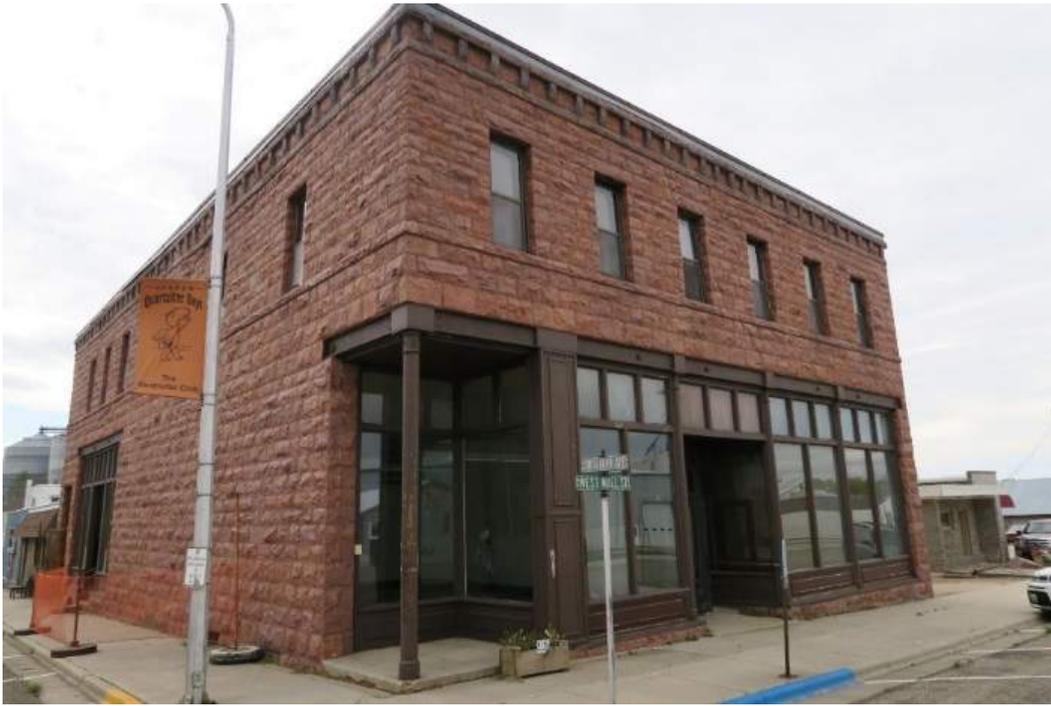
*Figure 27 Showing cut face stone*

On the north and east elevations, the exterior portion of wall consists of large, well-fitting, rectangular cut “face stone” laid in running bond (Figure 27). The condition of masonry on the north and east elevations varies. Barring the defects noted below, this exterior masonry is generally rectilinear, plumb and in good condition. Along the east elevation, near the roof level, there is a portion of wall that has deflected out-of-plane up to approximately 6 inches toward the interior of the building. In figure 28, the orange highlights indicate the defect area and red highlight indicates where the defect is most pronounced. Reflecting the exterior condition, on the interior of the building at this east wall location, the wall bulges inward approximately 6 inches (Figure 29). There is a portion of the north facade that also bulges slightly to the interior, though to a lesser degree. At the windows near these areas on the east and north facades sand is present on the window sills, indicating the complete breakdown of lime-based mortar within. At the south end of the east elevation, above the steel entrance lintel, there are large, rectangular stones with loose or missing mortar (red dashed rectangle in Figure 30).

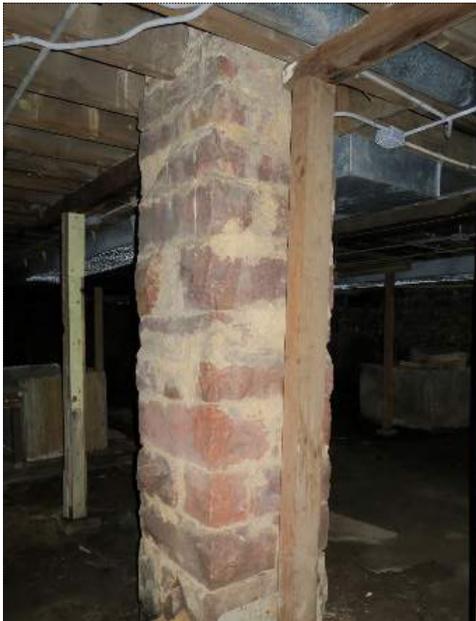
*Figure 33 Masonry columns at basement*

Along the center of the building three masonry columns spaced approximately 20-feet apart, support steel columns and wood floor framing above. These masonry columns are approximately 24-inches square and consist of mortared roughly rectangular stone (Figure 33)

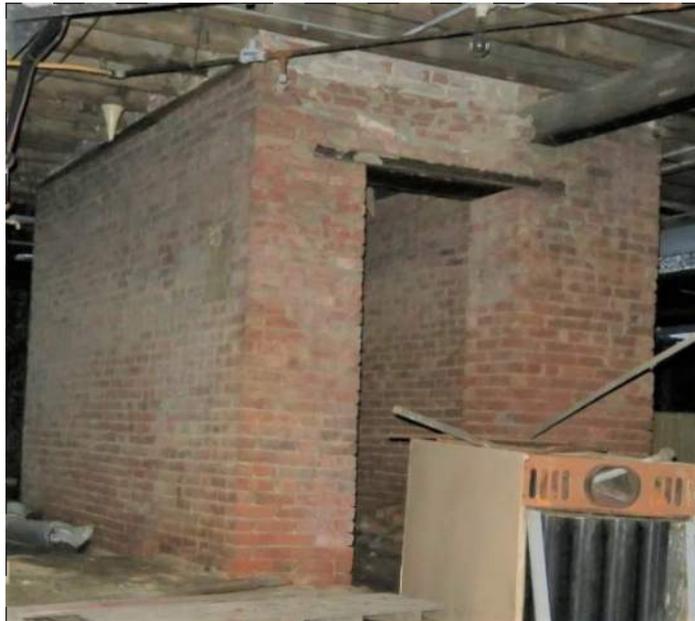
*Figure 34 Basement vault*

In the northwest quadrant of the basement there is an 8-foot x 12-foot brick enclosure with a cast-in-place concrete cap. Originally, this may have been a vault, the foundation for a vault or safe above, or cold storage area. The brick walls are approximately 16-inches thick. There is a steel lintel over the opening and steel rails within the concrete cap (Figure 34).

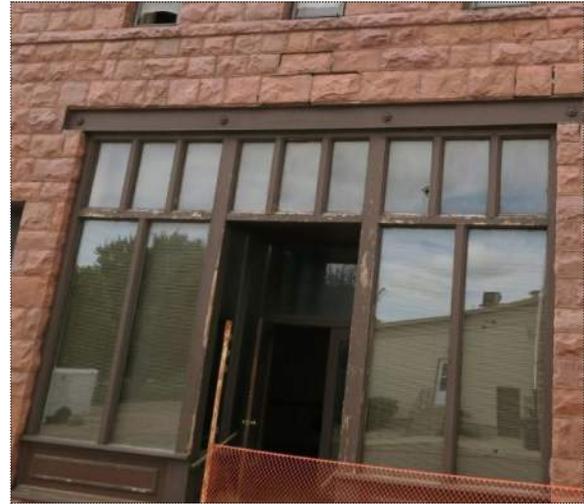
Figure 41 Steel lintel beam at east facade

On the east face of the building, a single 12-inch deep steel lintel beam supports the masonry bearing wall above the entrance storefront. This lintel has deflected and the masonry above has shifted with loose and missing mortar (Figure 41). Based on the observed deflection, it is likely that the intermediate storefront verticals are not load bearing.

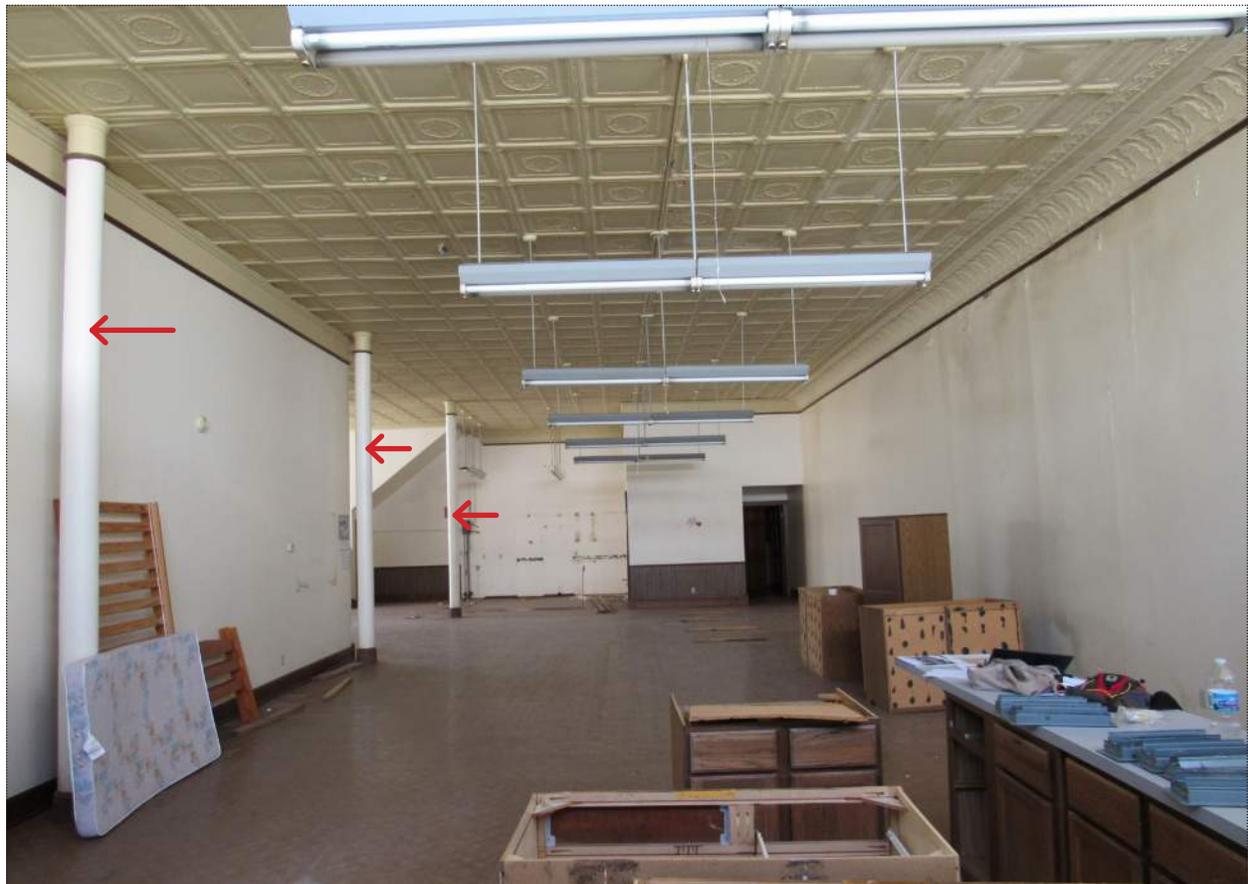
Figure 42 Steel columns at interior

On the interior ground level, equally spaced along the center of the building, three steel columns bear on masonry columns below and support steel beams above. These columns are 8-inches in outside diameter (highlighted by red arrows in Figure 42). The interior columns appear to be in good condition and show no sign of buckling or distress.

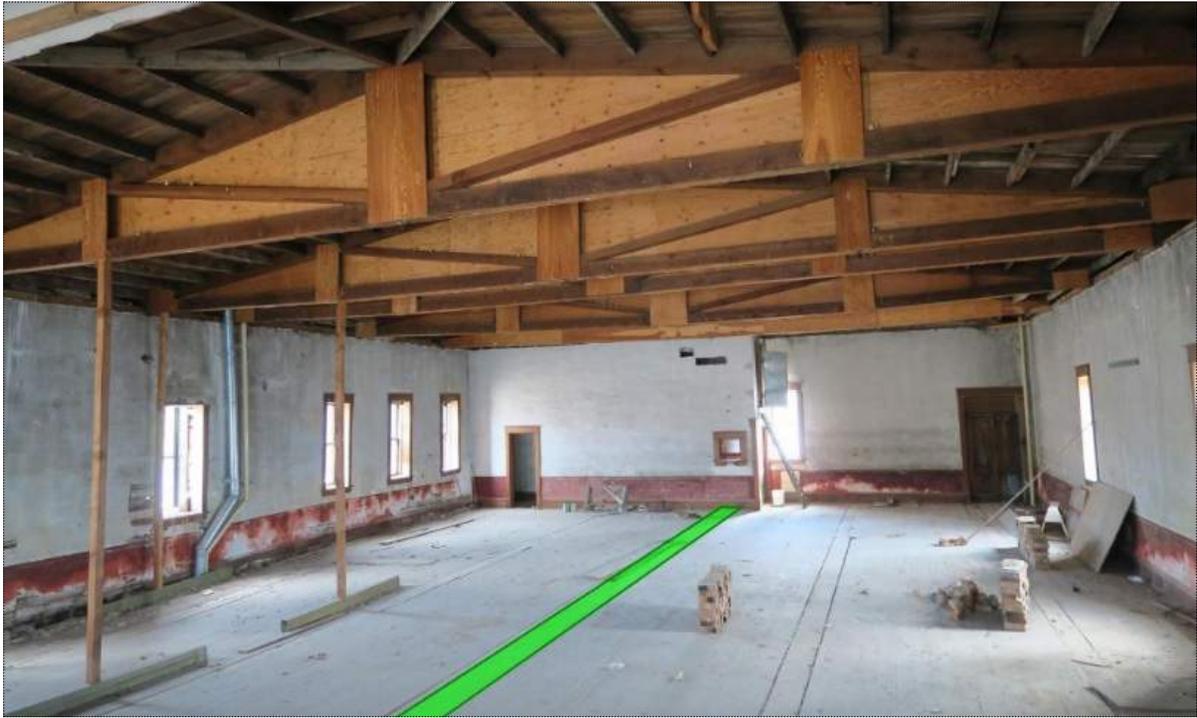
*Figure 43 Steel beam span shown in green*

At the upper level floor framing, along the center of the building, steel beams span between steel columns below (green highlight in Figure 43). These steel beams are in the same plane as the wood floor joists and are 12-inches deep with a flange width of 5-5/8-inches. These steel beams show no signs of excessive deflection from above or below.

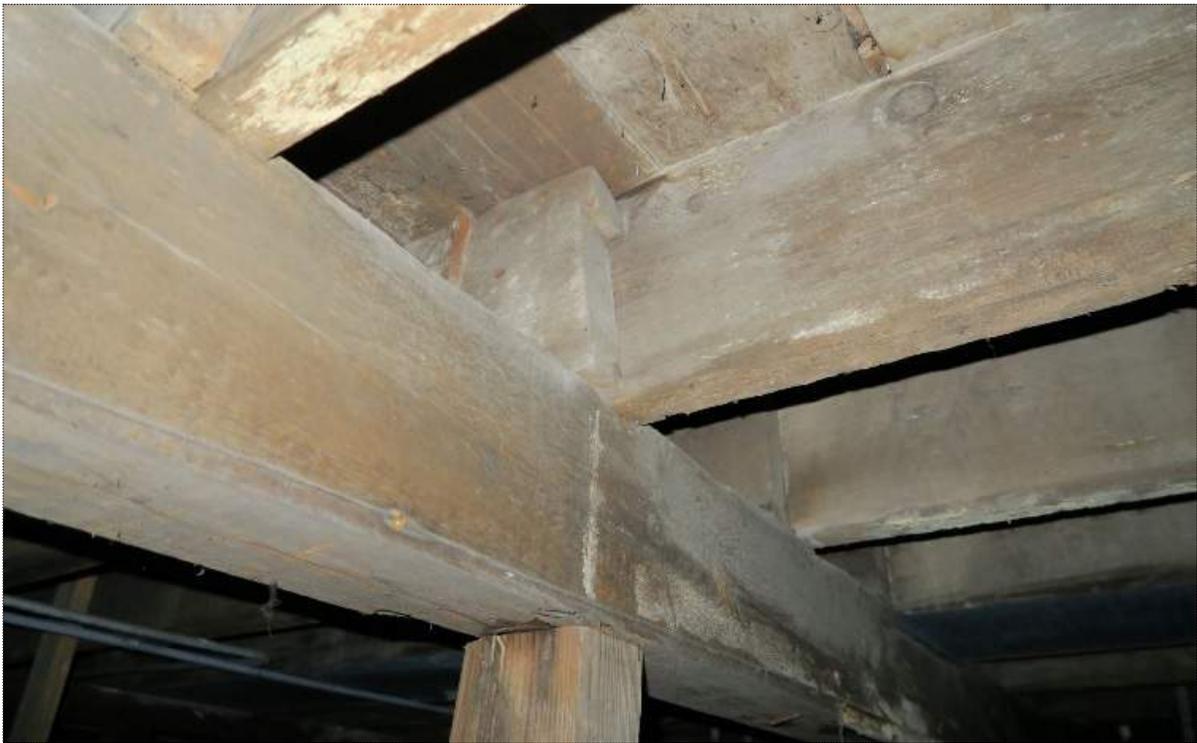
*Figure 44 Assumed original wood beams at basement level*

Running north-south, two lines spaced approximately 15-feet apart, 6-inch wide x 8-inch deep wood beams support wood floor joists (Figure 44). Due to the patina, size and relation to the wood floor joists, these two beam lines are believed to be original.

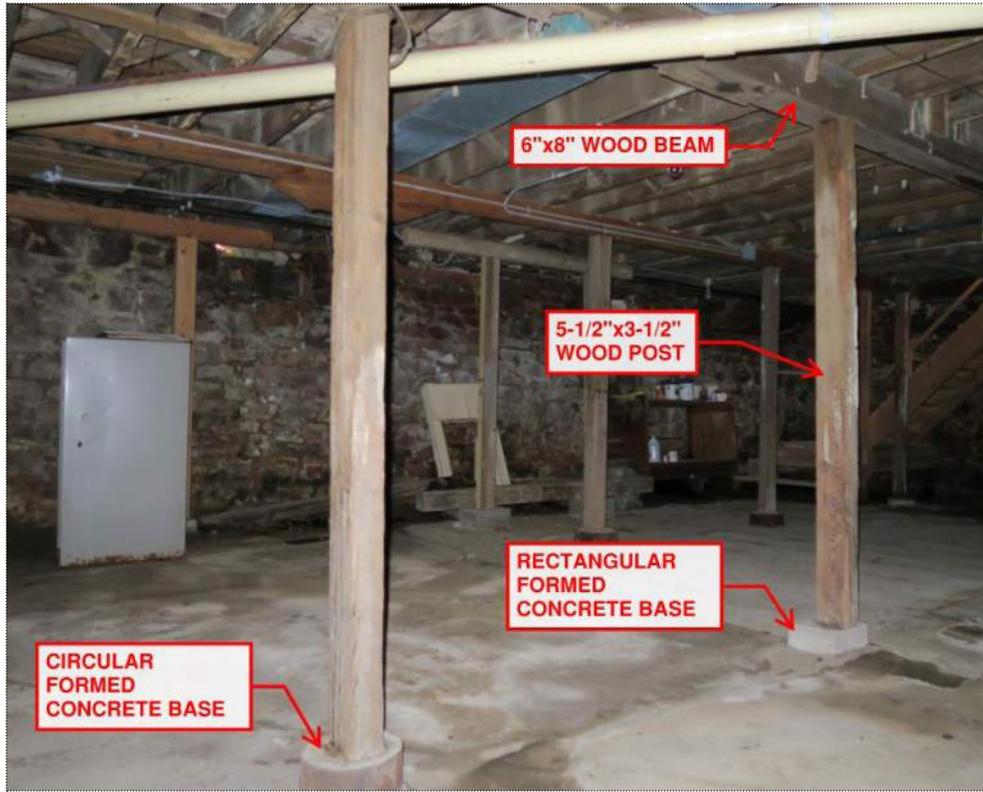
The wood joist framing of the ground floor is supported by a series of wood posts and beams visible from the basement. At least two types of wood post-and-beam lines were observed. From their distinctly different size, location, and patina, it is believed these are from different time periods and previous efforts to bolster the ground floor framing above.

Figure 45 Differentiated structural support at basement level

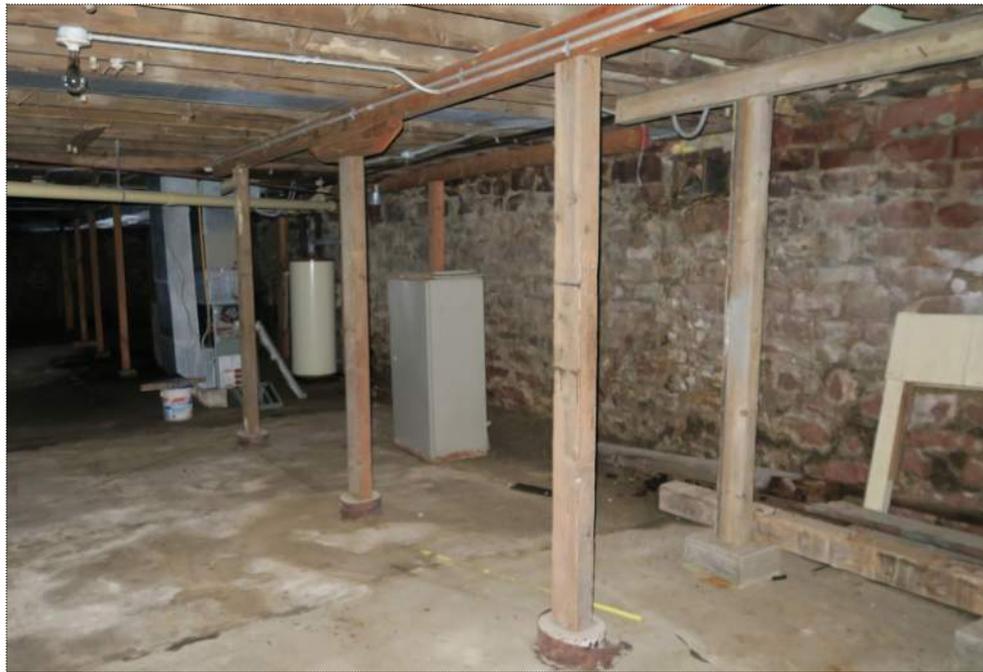
Figure 46 Additional beams at basement

Running north-south between the original beam lines, additional wood post-and-beam lines have been added. These beam lines are discontinuous and do not consistently reach all the way across the building from exterior wall to exterior wall. The beams measure 3-3/8-inch wide x 5-5/8-inch deep and the posts measure 5-1/2-inch x 3-1/2-inch (Figure 18). In some cases, these newer posts rest on formed concrete bases and in other cases they rest on precast concrete pieces.

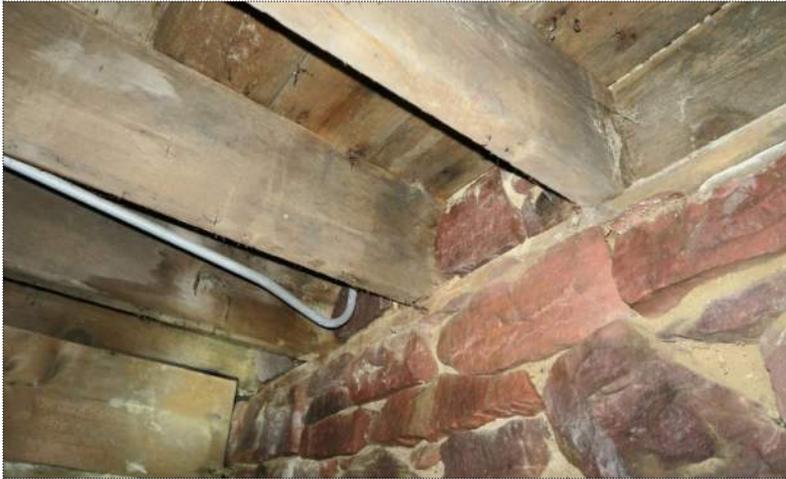
At the east and west masonry walls, the joists typically bear on a wood sill plate. The sill plate and joist ends are embedded into the masonry (Figure 47). On the east side the sill plate and joist ends are rotted and deteriorated. On the west side, deterioration is less severe. In some locations on the east and west sides, an additional line of post-and-beams has been added at the face-of-wall.

*Figure 47 Bearing point at joist ends in basement*

contact. It is preferable that specific galvanized hardware be used where wood bears on concrete or masonry. Where existing wood post bases have signs of moisture damage, it is recommended that they be cut and re-supported using galvanized hardware.

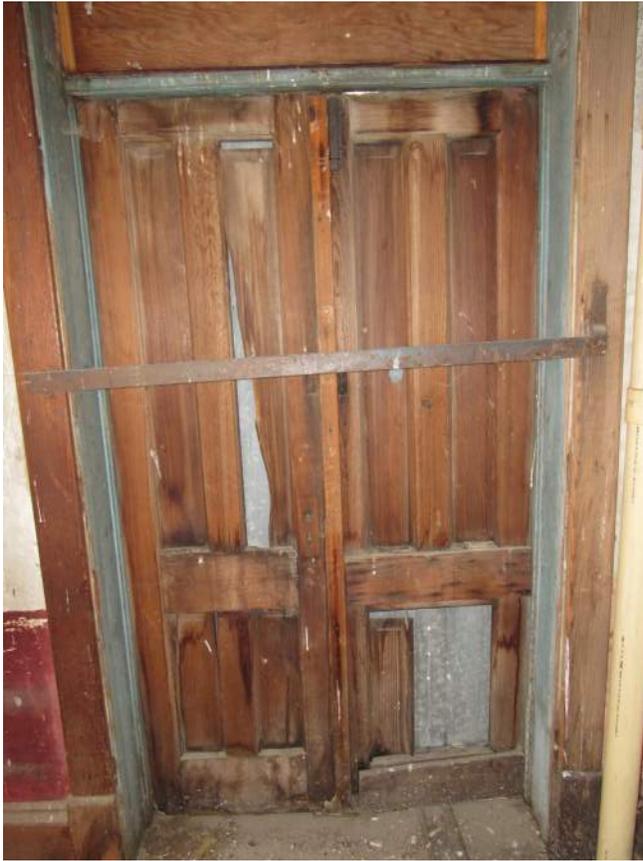
At the southwest corner of the building at the second floor is a set of double doors that has been covered with what appears to be sheet metal at the exterior. The doors and frame with transom are visible from the interior and appear to date from the period of significance. The transom sash appears to be missing. The doors are missing operation hardware, but they feature what appears to be the original top lock hardware. The doors themselves are in poor condition, with large portions of stiles, rails and panels separated and missing (Figure 57). There is a similar covered opening visible at the exterior on the first floor, but it is furred out to create the restrooms at the interior. It is unknown if a door is located within the opening.

Figure 57 Covered exterior door at southwest corner

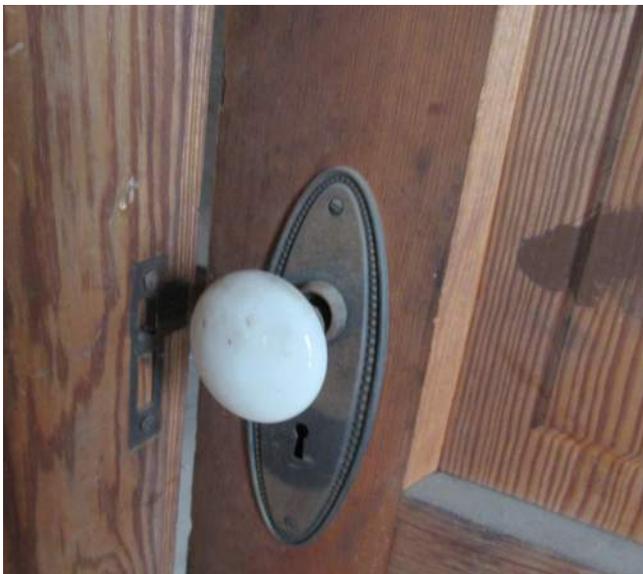
There are several interior doors at the second floor that appear to be original. These vary in condition from fair to poor. Many of these feature original hardware (Figure 58-59).

Figure 59 Original interior hardware

The door at the bottom of the stairs to the second floor should be retained and repaired. All interior doors at the second floor should be retained and repaired where required. The door leading into the east side of the room at the west side of the stage features a charred spot on the interior where it was clearly swung too close to a gas light, the fittings which are still extant on the wall (Figure 58). It is recommended that the fittings and charred spot are left as is, as an interesting illustration of some of the dangers of early building systems.

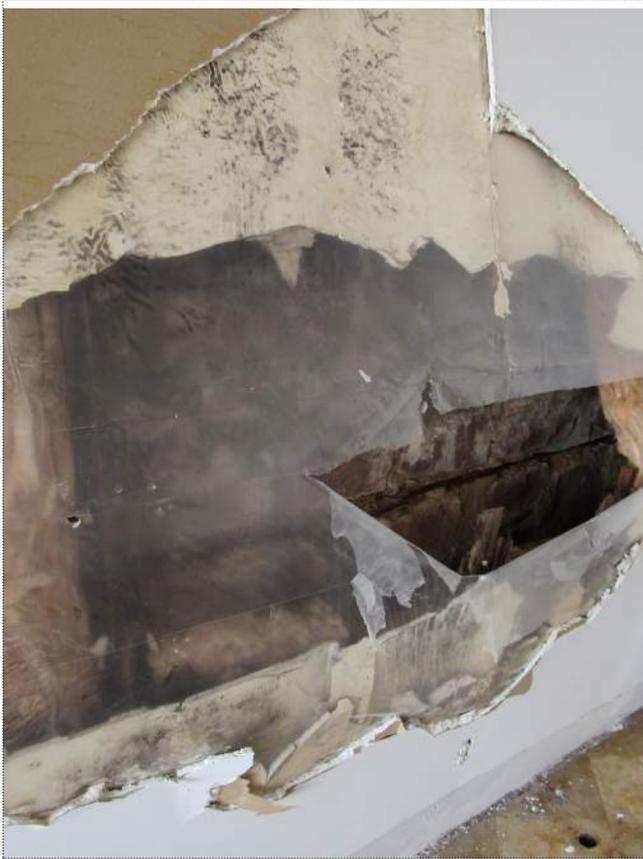
*Figure 61 Wall assembly at northeast corner before collapse. Note gyp board over vapor barrier over gyp board.*

At the first floor, it appears that the original lath and plaster furring and finishes have been completely removed to install modern electrical wiring and batt insulation. At the time of the assessment, the interior furring was failing at the north side of the east wall and the interior of the wall could be observed. The assembly appeared to be modern 2x wood framing with batt insulation attached to the original nailing strips embedded in the masonry, with gyp board nailed to the framing. Over this was a vapor barrier with an additional gyp layer over that (Figure 61). This is not a standard assembly. It is possibly that, following the original installation of the new furring, insulation, and gyp board, moisture at the finished surface of the wall continued to be a problem. At this point the vapor barrier may have been added to control this, which likely trapped the moisture on the other side of the wall, hastening the failure of the wood framing and its weak connection to the wall at the historic nailer strips. This condition would have been significantly worsened after the building stopped being conditioned in the early 2010s. As previously described this wall assembly has since failed completely and collapsed. It is not fully known why this has only occurred at this location. It is unknown if this is the only area where the vapor barrier and extra layer of gyp board was added at the first floor. No other walls at the first floor appear to be failing in a similar manner, and generally appear in good condition. The other exterior perimeter walls also all feature the original pressed-metal cornice. It is possible the cornice was removed when the additional thickness of the vapor barrier and extra gyp board were added at this location. This could mean that the other walls do not have the vapor barrier and additional layer of gyp board. This may have allowed better vapor transmission at those locations which has helped to prevent rot at the interior of the furring.

As previously mentioned in the masonry section, it is recommended that the interior finishes be completely removed from both the first and second floor. This will ensure that the assembly at the first floor isn't causing more harm than good, as in the north side of the east wall. It will allow for inspection and correction of masonry issues not currently observable. Finally, it would be the first step in providing more permanent structural and thermal improvements at the exterior wall, similar to the sketch in figure 39. If wall finishes are removed, care should be taken to retain the pressed metal ceiling and crown molding in place at the first floor. At the second floor all window and door casing and wood trims should be carefully salvaged for reinstallation following abatement and removal of plaster walls.

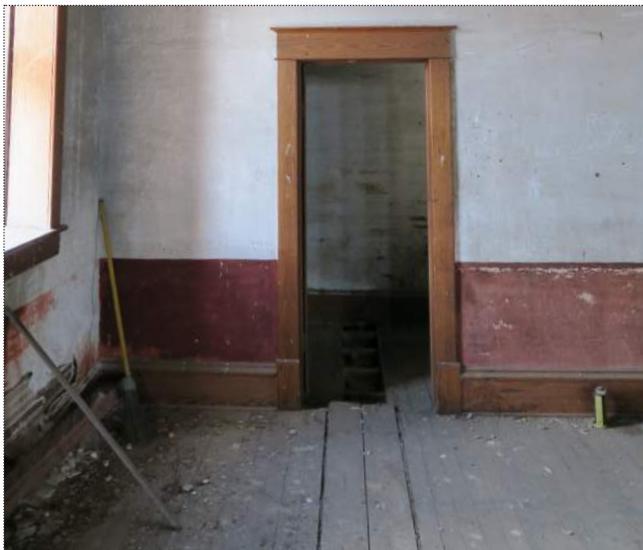
*Figure 63 Southeast cornering of second floor. Note original wood base and door casing, painted red “wainscot” and finish floor boards removed to install blown-in insulation.*

At the second floors the original lath and plaster wall finishes remain. A hazardous materials report commissioned by a previous owner indicated that the plaster at the second floor (excluding the stairway) contains 2% chrysotile asbestos. The remaining plaster, at both the stairway and second floor, is quite thin, only 1/4"-3/16" thick (Figure 62). Typically, plaster would include 3 layers: a rough base layer called a scratch coat; an intermediate layer called a brown coat; and a finish layer called a top coat. A typical plaster assembly would be 3/4" to 1" thick. The plaster at Bauman Hall appears to only contain two layers. That being said, the plaster is in no worse condition than you might expect for a building that has been unused for so long. The plaster is intact in many locations. The plaster has fallen from the lath in other locations, particularly in the areas previously mentioned where the masonry walls are bowing in. The plaster would be easily repairable if it weren't for the asbestos content. It isn't likely that it will be possible to repair the existing plaster walls. They will either need to be encapsulated, likely with a layer of gyp board, or completely removed. The walls at the second floor feature a red painted strip meant to simulate a wainscot (Figure 63). It is recommended that this feature be recreated if the wall finishes are rehabilitated.

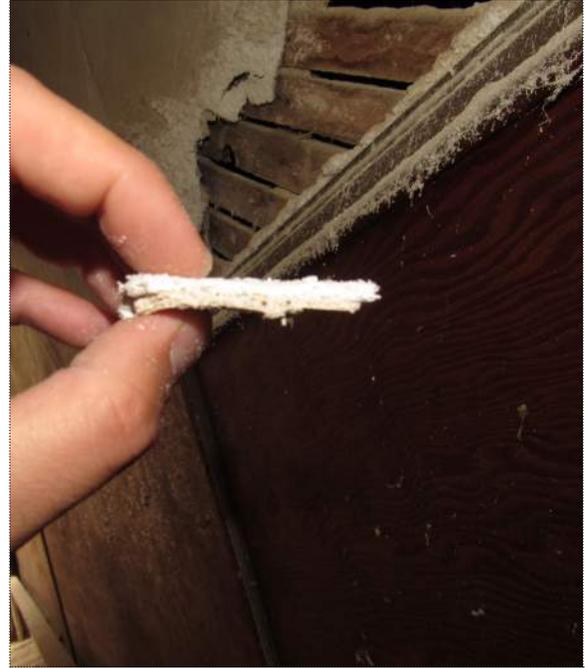
*Figure 62 Typical plaster thickness at stairs and second floor*

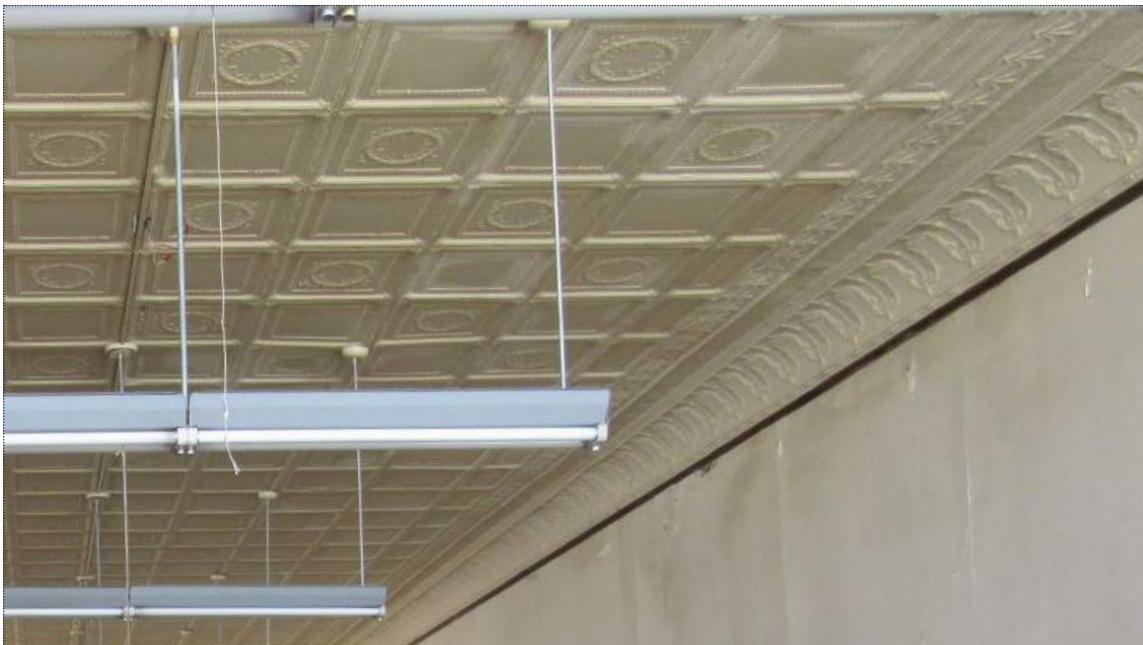
*Figure 66 Detail of pressed metal ceilings and crown molding at first floor*

Ceilings have been discussed at length in other areas of the report. At the first floor the pressed metal ceilings and crown molding should be retained and repaired to match existing where required. At the second floor a hard lid ceiling should be reinstalled. See *Wood Framing Discussion* on page 41 for further information (Figure 66).

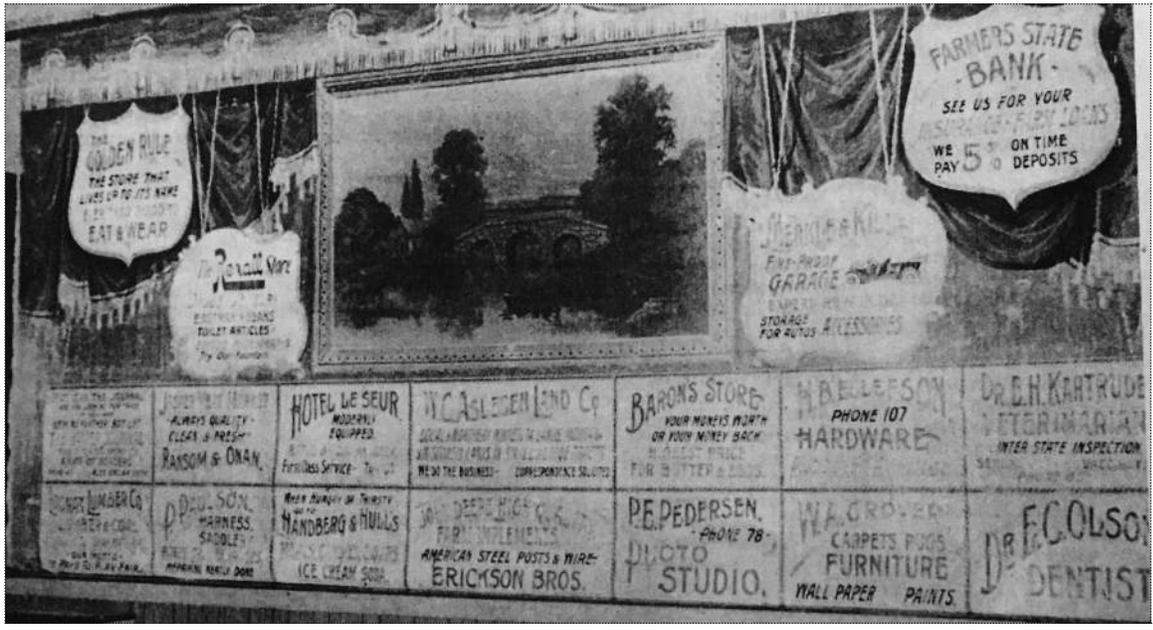
Figure 67 Original drop curtain, currently housed at the Jasper Historical Society (courtesy Jasper Historical Society)

The stage at the north side of the second story is an important character defining feature and should be retained and repaired. The area beneath the stage should be cleaned of all accumulated refuse and the wood beadboard paneling along the front should be repaired with paneling to match existing. The Jasper Historical Society retains the original drop curtain from the stage (Figure 67). Once the conditions at the interior of Bauman Hall are appropriately renovated, the curtain should be returned to Bauman Hall for display. Appropriate conservation measures should be undertaken on the curtain itself prior to display.

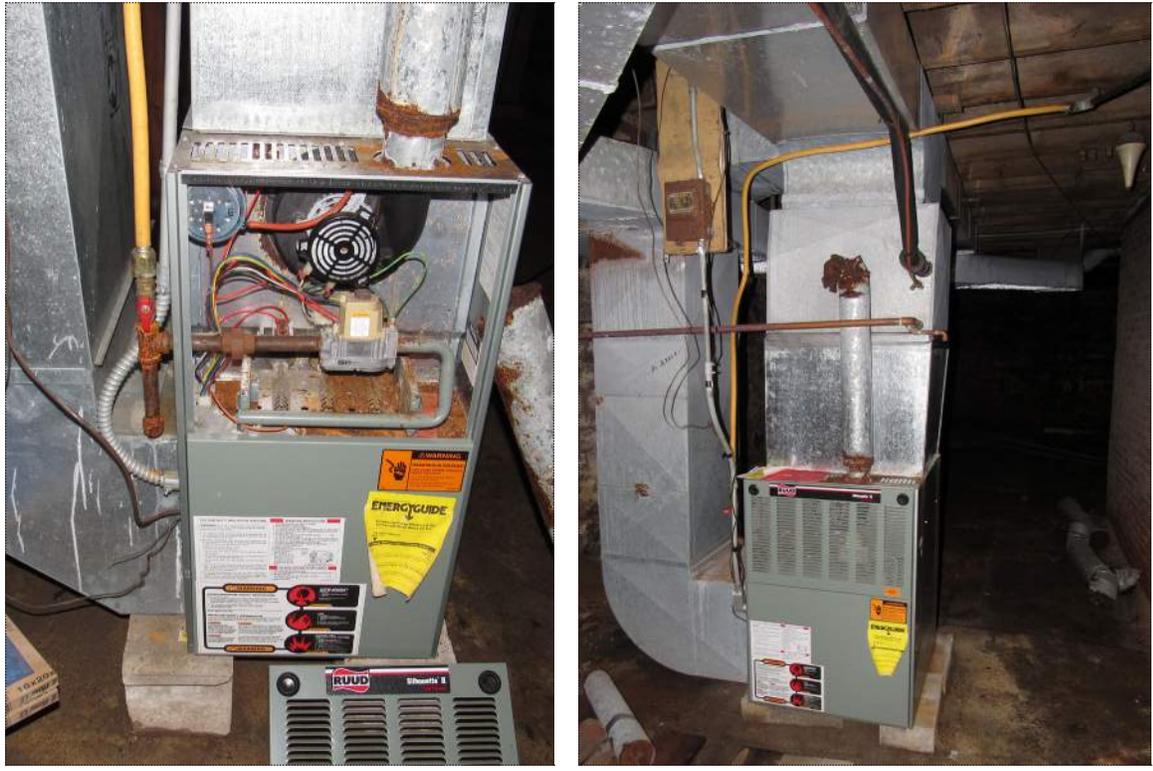
Figure 68 Photos of the two existing forced-air furnaces

Currently the building relies on forced-air furnaces that are well past their useful lives. It should be noted that these systems sat unused from 2011 until 2019 when they were recently restarted. Radiant heat is a more efficient way to provide heat at the wall surface and is what the building would have had originally. Ultimately, it is recommended to install a boiler and radiators be installed at both levels. At the minimum ductwork to the second floor should be provided in order to maintain some degree of conditioning during the coldest months. While inefficient, this will be better for the masonry walls as well as aiding the prevention of excessive snow loads at the roof.

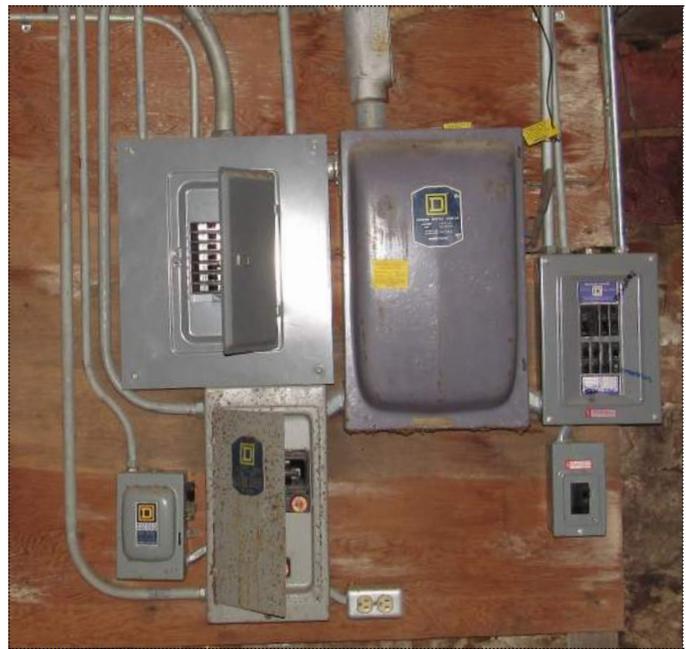
Figure 71 Existing electrical panels. Inspection notes indicate that they were inspected in 1981

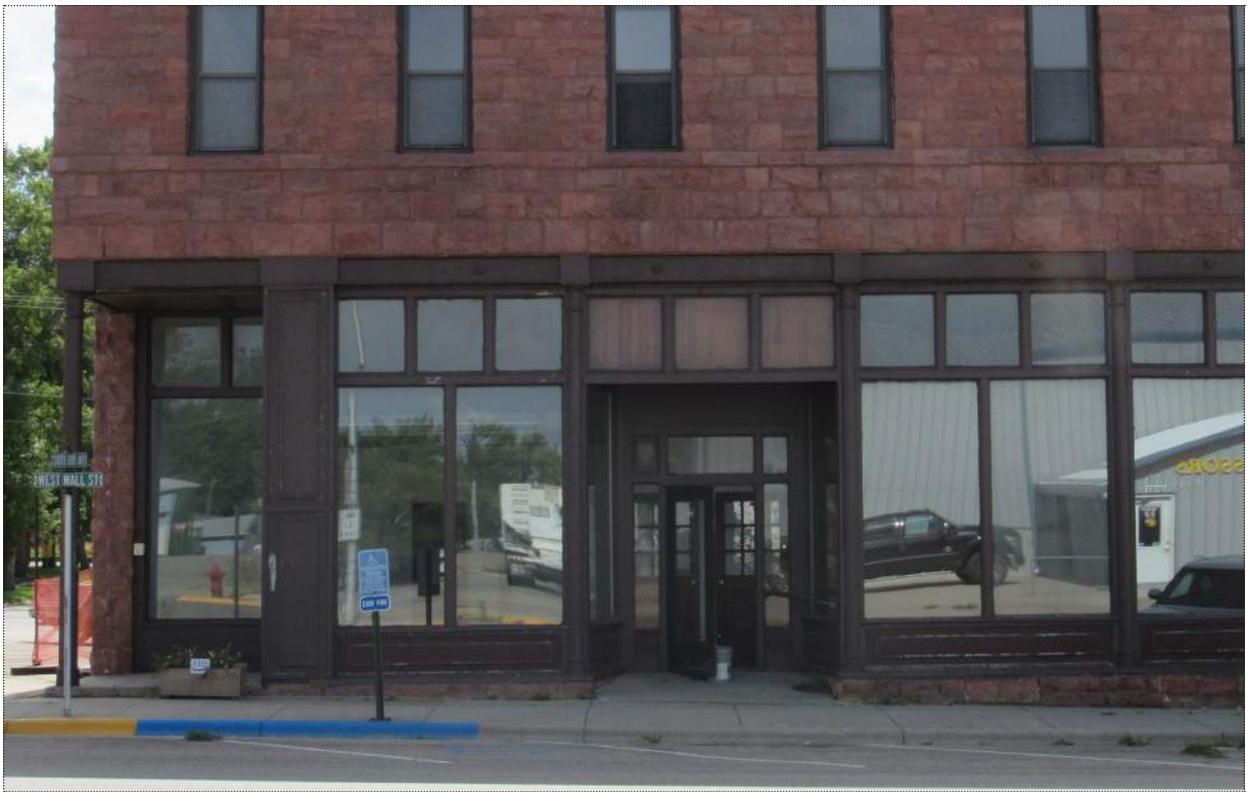
*Figure 74 Accessible parking spot at street and main entrance to building*

The building does not feature a parking lot, but there is currently an accessible parking spot on the street at the north side of the building with access to a curb cut at the corner of Wall St. and Burr Ave. There is

a short steep ramp into the vestibule at the north side of the building that does not meet code. However, since the corner is higher than the sidewalk at the entrance, a sloped walk could be provided from near the corner that would meet the code maximum for rise (Figure 74).
